2011 STUDY OF THE LONG ISLAND CREEK WATERSHED: SANDY SPRINGS, GEORGIA
Directed by Dr. Mark Patterson and Dr. Nancy Hoalst-Pullen

June 28, 2011

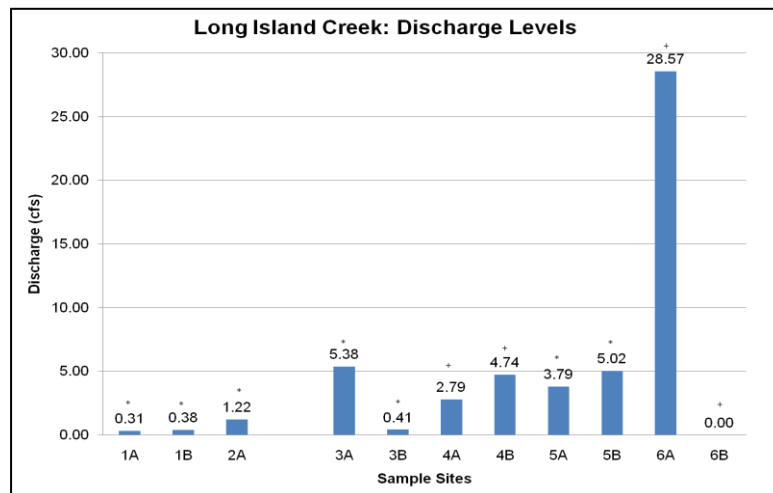
Figure 2: Long Island Creek: Discharge Level

For the watershed as a whole, it is important to understand the discharge levels and air and water temperatures. The average discharge level of the watershed is 4.78 cfs/100 mL. As seen in Figure 2, the discharge mainly increases from the headwaters to where the creek flows into the Chattahoochee River with the exception being site 3A. Temperature, regardless of whether water or air is relatively the same. This can be observed in Figure 3 where it can also be seen that the only exception is a slight variance from the average water

The * refers to a measurement on June 16 and a + is a measurement from June 23. Note that no data was collected for 2B and 6B is 0.00 because it is a pool.

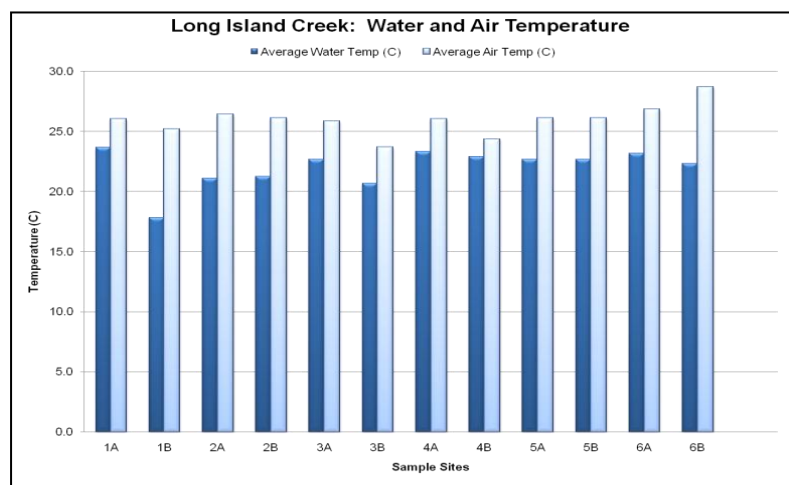
Figure 3: Long Island Creek: Water and Air

temperature at site 1B where the water temperature is 17 degrees Celsius. The average air temperature for the watershed is 25.8 degrees Celsius and the average water temperature is 22.3 degrees Celsius.

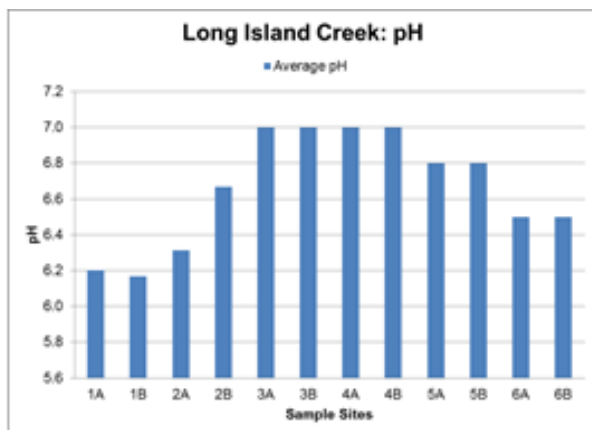
Figure 11: Long Island Creek pH Level

Average pH for both sample sites were 6.5 (Figure 11). This is the lowest value within the range of optimal conditions for most aquatic organisms (AAS, nd). The average dissolved oxygen for site 6 was 5.6 mg/L for sample site 6A and 5.4 mg/L for sample site 6B (Figure 13). These dissolved oxygen levels fall within the healthy range specified for the biological community. According to Georgia Adopt-A-Stream, levels of 5 to 6 ppm (or mg/L) are required by most organisms for growth and activity (AAS, nd). Moreover, it is important to note that, during the summer organisms require more oxygen due to increased activity in warmer water (AAS, nd). The considerable presence of decaying organic material in the waters of site 6 decreases oxygen capacity, which might explain the lower average dissolved oxygen in comparison to most of the other sites.

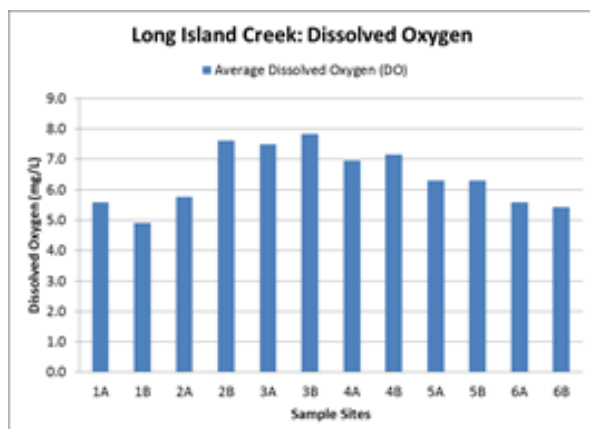
Figure 13: Long Island Creek Dissolved Oxygen

Looking at dissolved oxygen, in both sites and comparing their levels to the other sites in this study, Sites 3A and 3B have some of the healthiest amounts (Figure 13). This is a good influence to the site's biotic integrity, species variation, and numerosity within each species present. The level of dissolved oxygen in each of the Sites, 3A and 3B, came out higher than hypothesized. This is not to say that it is an accurate description of the health of the site. Site's 3A and 3B are in need of attention to their environment and surroundings, land use during urban growth and proper disposal of residential waste if humanity wants to help this site's percentage of probability for positive change to the Long Island Watershed.

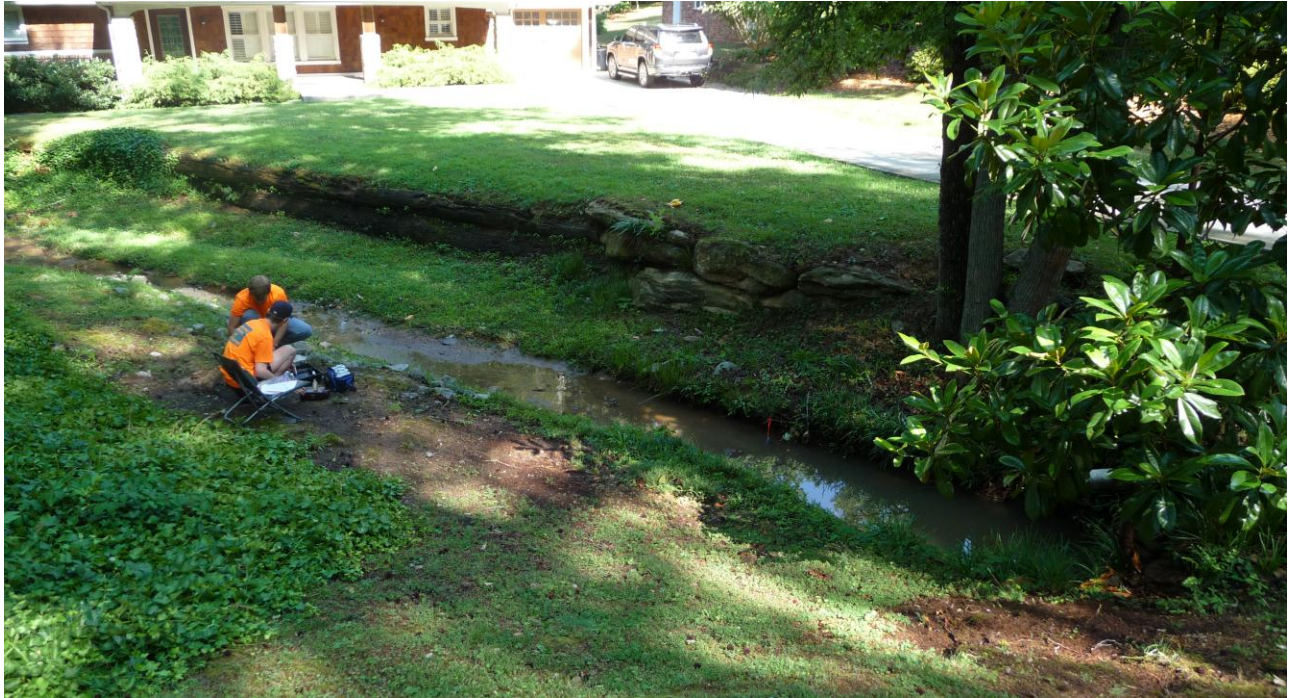
Site 1, June 21, 2011

Site 1 is comprised of two separate head-water streams. The two sample sites, referred to as sites 1A and 1B are both located in a residential neighborhood comprised of similar single family homes on lots ranging from one-half acre to two-acres in size. Both streams are perennial and share the feature of a culvert running through them. The two were selected for their similarity and proximity, being roughly one-half mile apart latitudinal. Both streams are at the low point where water runs into the catch basin. All the runoff water eventually makes its way into the low points. There were multiple factors that affected the streams including impervious surfaces, nitrate and phosphate runoff from yards, and sewer lines.

Site 1A was located at a home at 6126 Kayron Drive and flows East to West. A culvert that runs under the street is where the first signs of water flow can be noticed. Unless there is a heavy rainfall, the amount of flow in this stream is very minimal. In addition to the flow that comes under the road, a 6 inch PVC overflow pipe brings in runoff from the areas that are at higher elevations. The stream has an average depth of 1.72 inches and an average width of 192 inches. The average CFS flow is 1.16 on June 16th. The average amount of nitrate in the water was .18 mg/L and phosphate levels were less than 1 mg/L (Table 2). The *E. coli* on June 7 was 733 cfu/100mL, and after the rain on June 21 the levels were too numerous to count (Table 3). The average air temperature is 26 degrees Celsius, and the average water temperature was 23.7 degrees Celsius (Figure 3). The pH count for site 1A was 6.2, which was slightly lower than the other site measurements (Figure 11). The average conductivity was 73.3 $\mu\text{S}/\text{cm}$, which was

Site 1B, located at 593 Lorell Terrace, flows East to West as does site 1A. A culvert exit also defines where one starts to see flow. The culvert is covered with vegetation, and the stream could not be easily accessed. The stream exits the culvert and runs along the bottom of a 4 to 6 foot walled stream bank. The estimated stream length is 120 feet from the culvert to the fence in the backyard where the stream flows into the wooded area to the west. The stream has an average depth of 1.94 inches and an average width of 144.5 inches. The average flow is .68 cfs/100 mL. These results can best be explained by the presence of a half dozen pools at the stream head and the rocky stream bottom. While a measurable depth is present in the pools, the only visible flow is too far downstream to be accurately assessed. The majority of water flow in this area is largely due to groundwater and runoff from the surrounding yards. The average nitrate level in the water for site 1B is .68 mg/L and phosphate levels are less than 1 mg/L (Table 2). The *E. coli* level on June 7th was 900 cfu/100mL and slightly increased after rainfall on June 21st to 2000 cfu/100mL (Table 3). The average air temperature is 25.2 degrees Celsius and the average water temperature is 17.8 degrees Celsius (Figure 3). The pH for site B was the same as site A (Figure 11). The average conductivity was 106.7 μ S/cm for this site (Figure 12). The average dissolved oxygen levels for site B was 4.9 mg/L (Figure 13). Finally, the stream discharge for site B was .38 cfs/100mL (Figure 2).

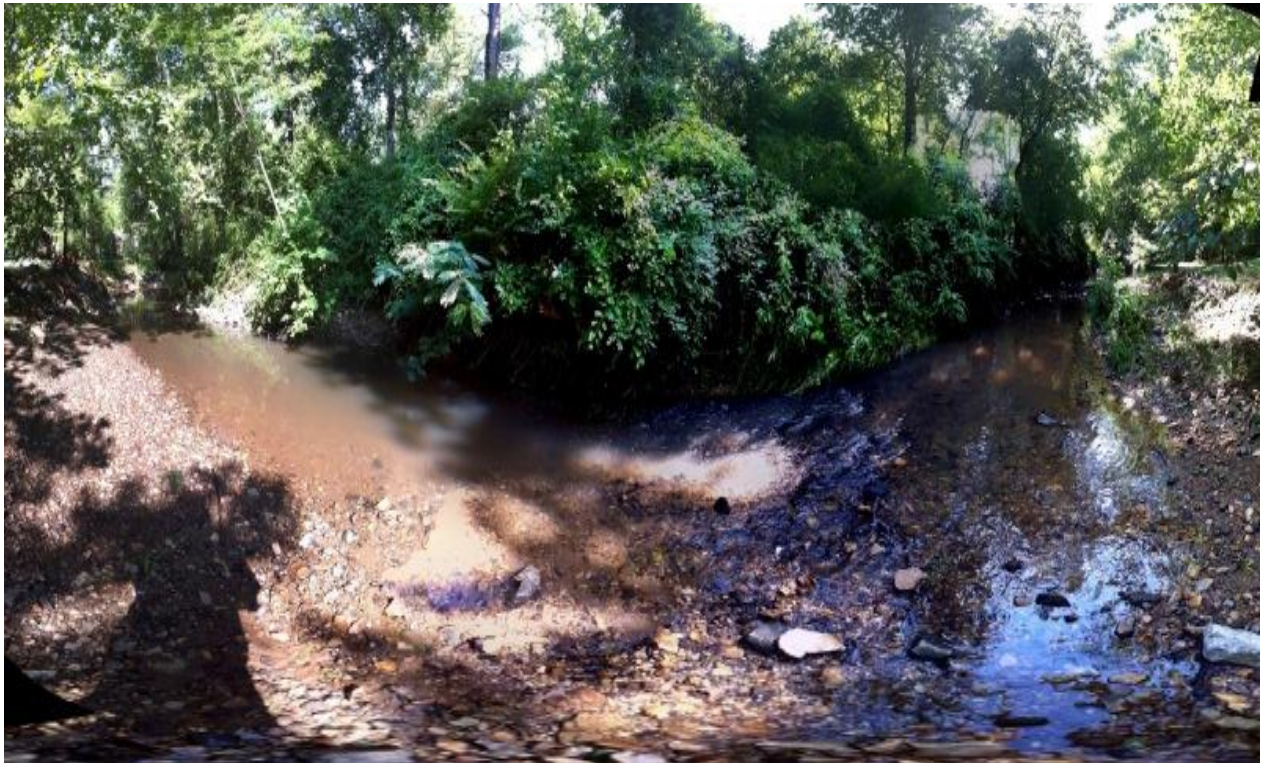
Site 4, June 21, 2011

Site 4 is located in the backyard of a home in a low density residential area off Glencastle Drive. In this section of the stream, the water flow is perennial. Though there are occasional bends from the natural flow, the site has a relatively straight stretch. At first glance the stream appears to be a healthy and clean aquatic environment. The site is full of wildlife including amphibians, reptiles, fish, and crustaceans. The banks are heavily vegetated, yet there are no aquatic plants in the stream reach. The fish were found to be from 1 to 6 inches in length.

Even though there is impairment to the Long Island Creek site 4 is relatively healthy for an urban stream. The main concerns at site 4 are the phosphate, *E. coli*, and erosion. According to the Georgia Department of Natural Resources the amount of impervious surface near site 4 is impacted if not mitigated. Development near the Long Island Creek watershed has impacted the ecosystem near the stream, and has caused many of the less tolerant species of fish to be replaced with more tolerant species. The higher phosphate levels at site 4 can be attributed to the residential area that the site is in. Erosion is the most severe problem at site 4; since the stream is straight before the site it is susceptible to flash floods.

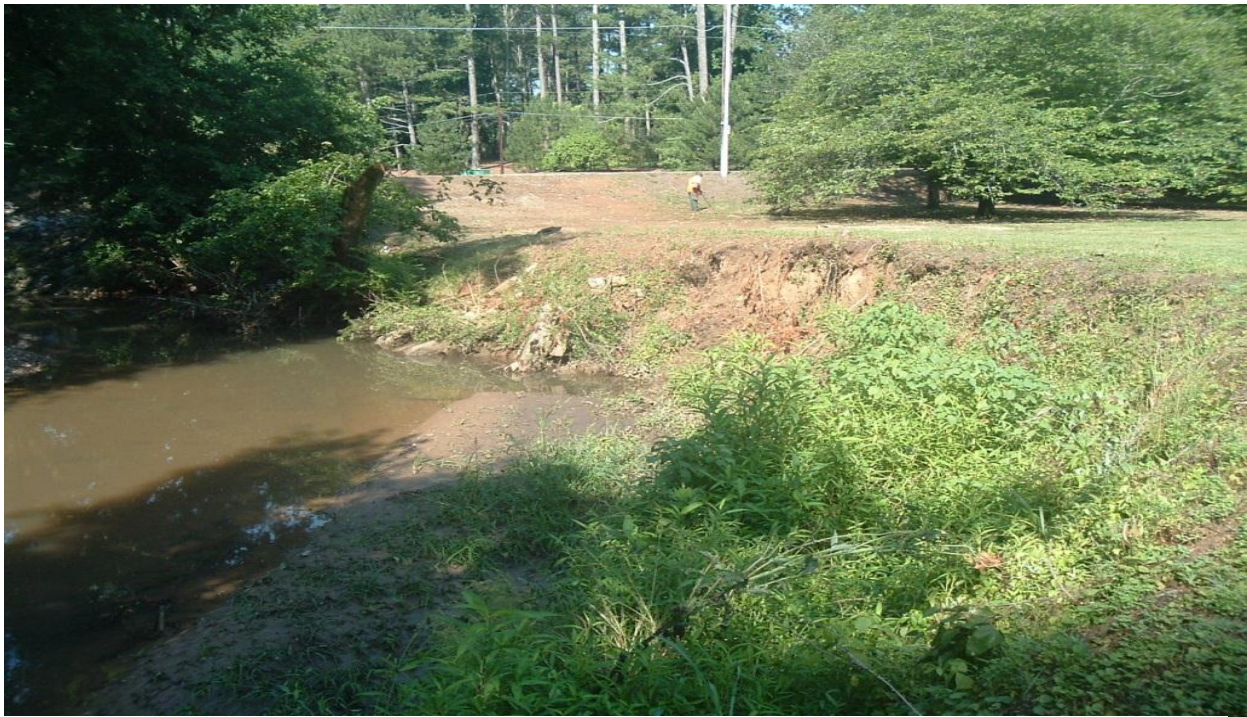
Site 5, June 16, 2011

Site 5 is located within a light residential area consisting of two large grassy lots with few trees on one side and the other side consisting of several large lots containing slightly more tree cover. Jett road separates the site's two sample areas; with 5A being downstream and 5B being upstream of the bridge. As shown in the cross section diagram (Figure E1) this site had an average stream width of 15.5 ft., an average depth of 0.45 ft. which equated to an average flow rate of 4.41 cubic feet per second. The stream reach, wherein the two sample areas were located, was 245m in length and contained five pools, three riffles, and two runs and,
